# Completion Report Draft

## Section III Text (Columns and Bases – Front Entrance)

### Part one: Prior Condition report of East Façade

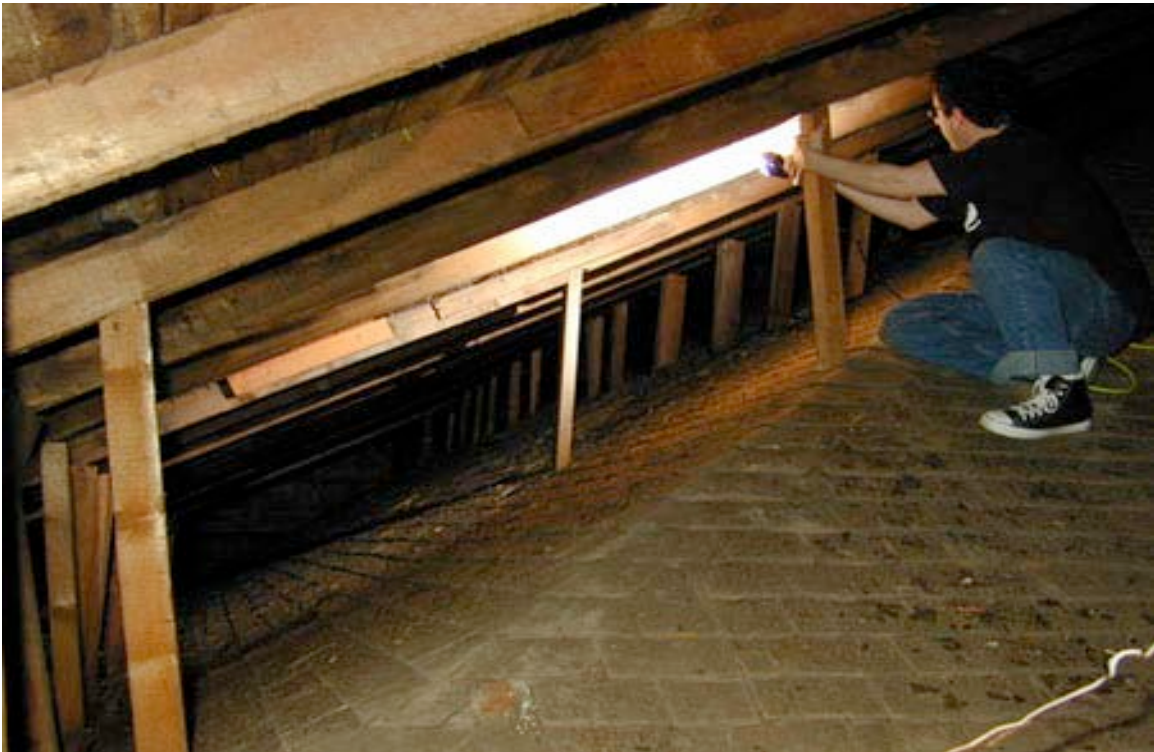
**Figure 1:** Standing on hipped roof with gable roof above

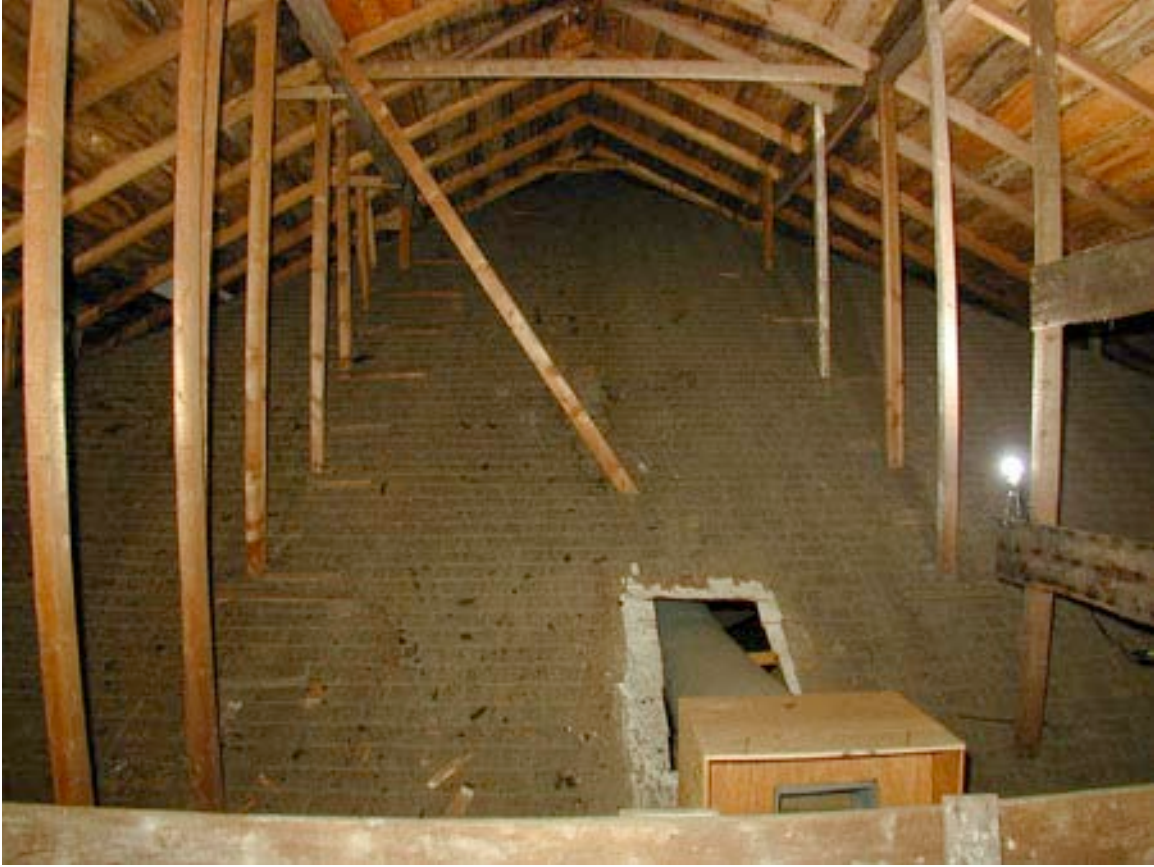
The present roof structure comprises the pediment and portico on the east façade and was constructed as an stylistic modernization and show of the Church's prominence. The original roof is a superior example of hip framing, but was never intended to support the massive gable roof that extends from it. The supporting members of the gable were undersized, too few in number, and incorrectly spaced to carry the roof load. Consequently, the original timbers of the hip roof were compromised (fig 9 IR97 and below).

**Figure 2:** undersized members are inadequate to support gable. Columns are taking the weight.

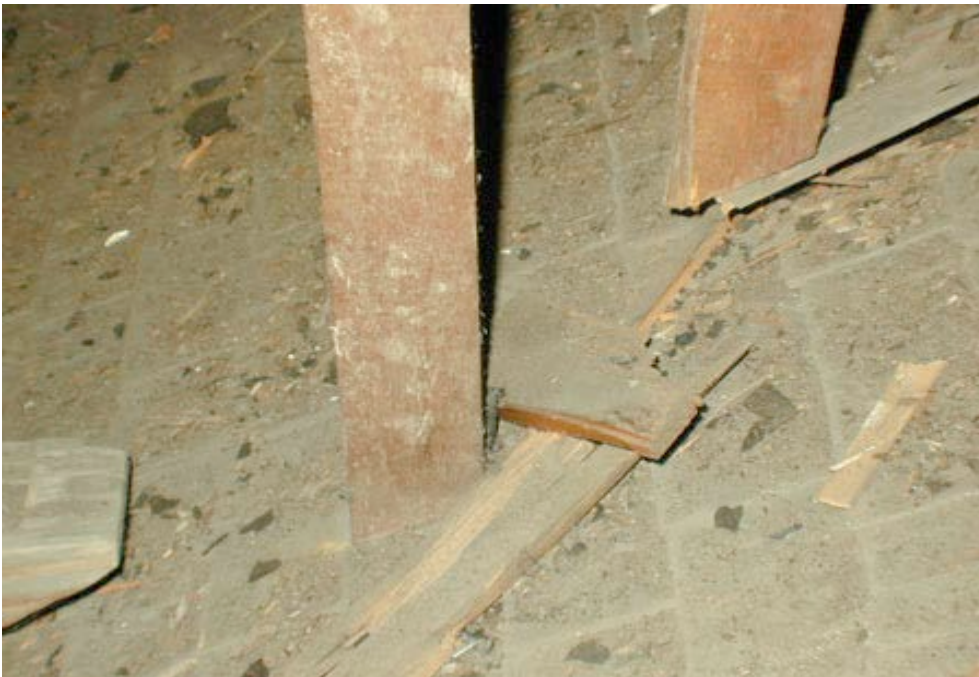
**Figure 3:** Detail of poor construction methods

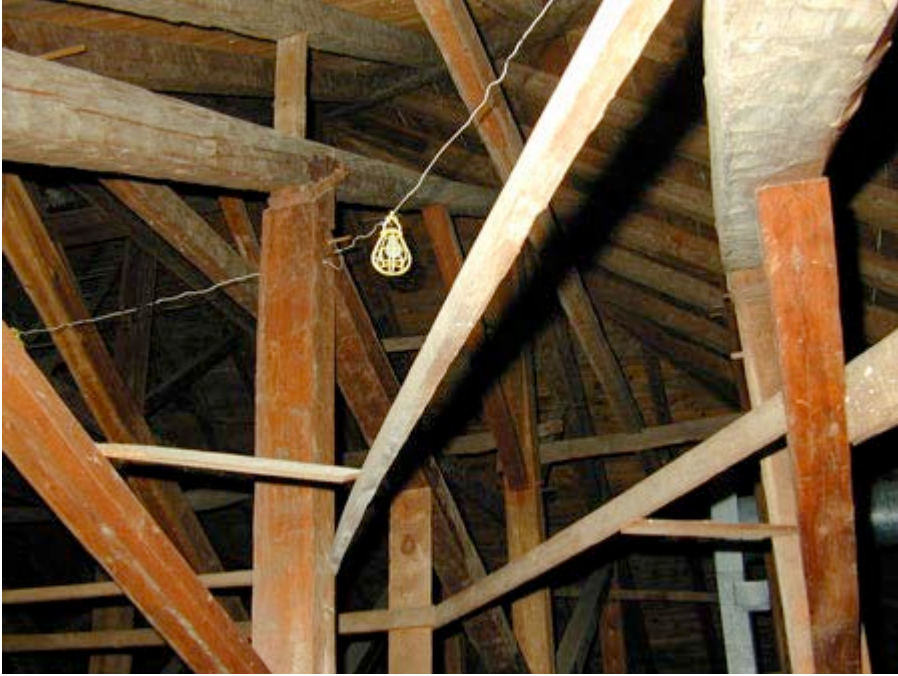
**Figure 4:** Roof details under the hipped roof. Note the size of the original timbers

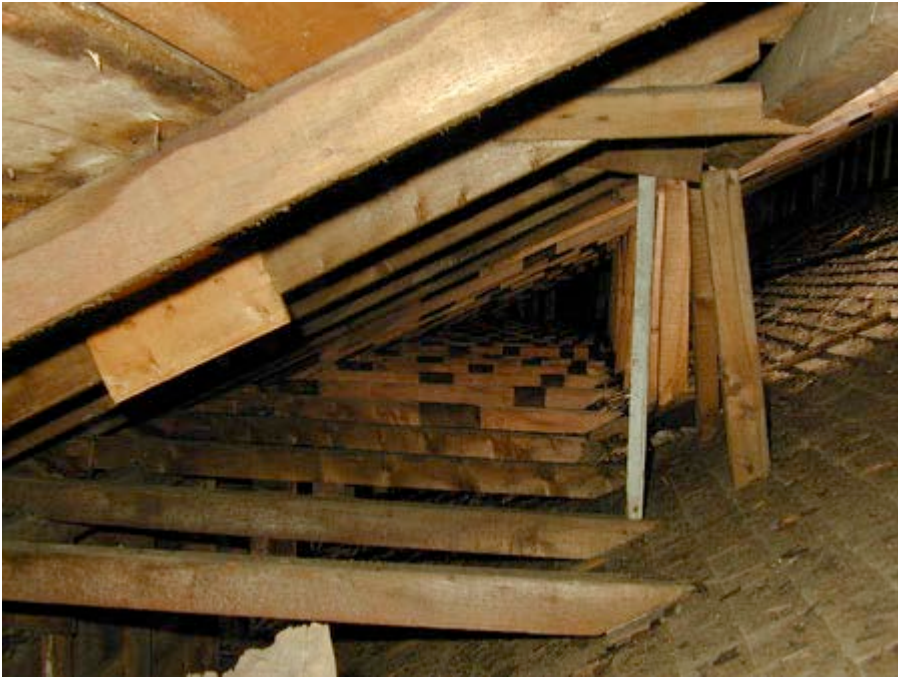
**Figure 5:** Here undersized outriggers struggle under their loads

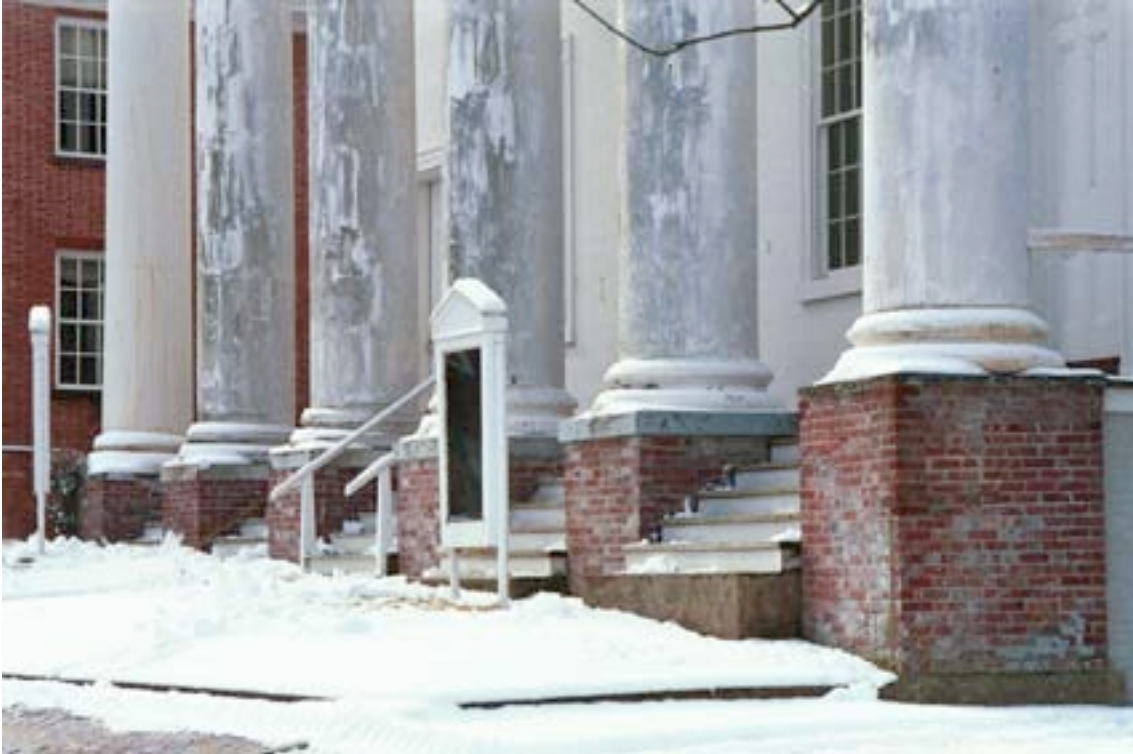
The effects of uneven weight distribution were further evident in the columns and bases that support the pediment. The scrolled volutes at the top of the columns show cracks resulting from the roof-load. It should also be noted that water, which had breached the column added additional weight that was not included in the original carrying capacity of the columns.

**Figure 6:** General conditions of bases prior to Phase II

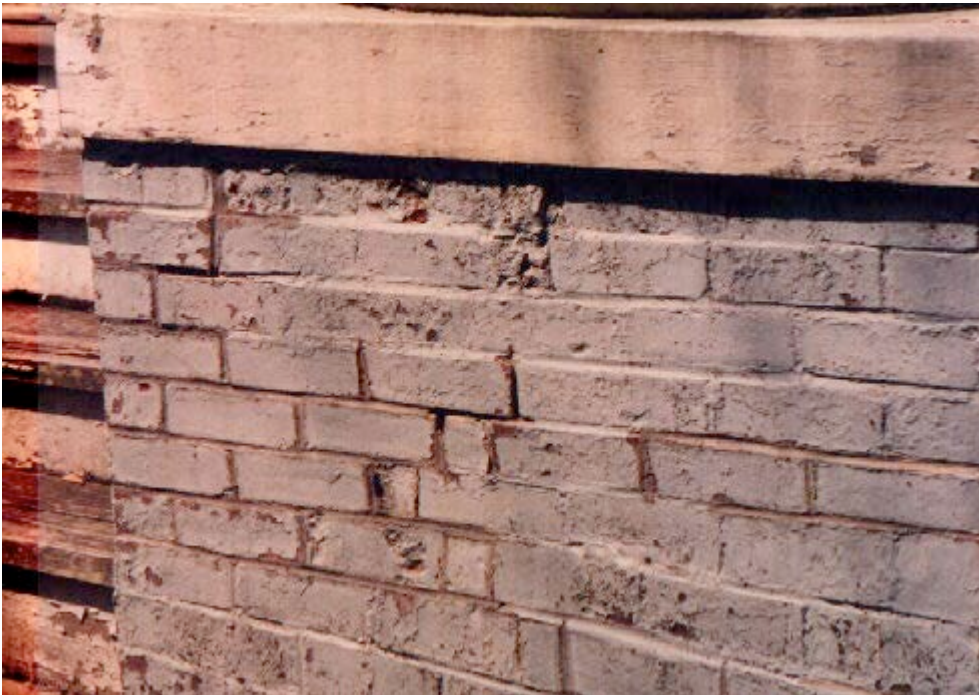
**Figure 7:** Missing mortar and cracking are the result of loading

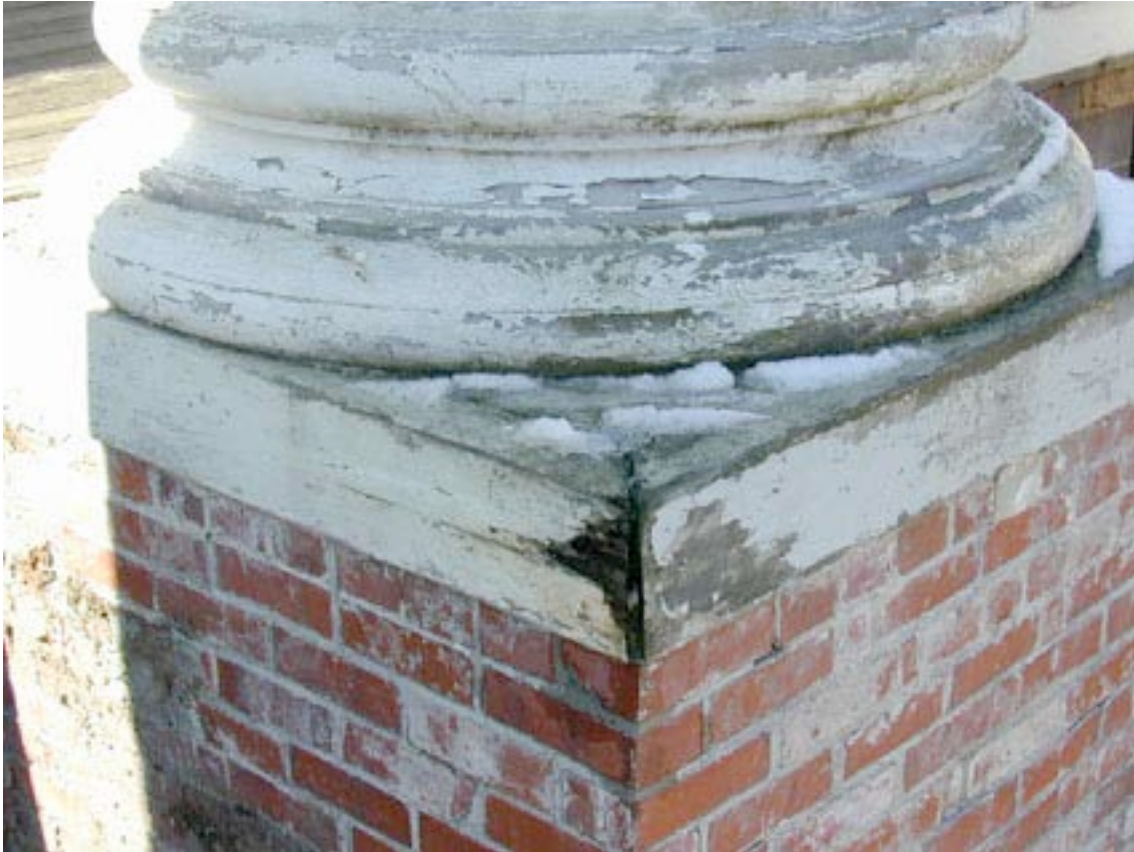
The pedestals bases suffered from various types of deterioration, resulting from improper calculation of the load, as well as water infiltration. Where the pedestals were clad in wood, rot occurred as a result of water penetration (fig 37 CA95). Without historic photographs, it is impossible to say whether or not the wooden cladding is original.

**Figure 8:** Water infiltration through columns has rotted wood bases

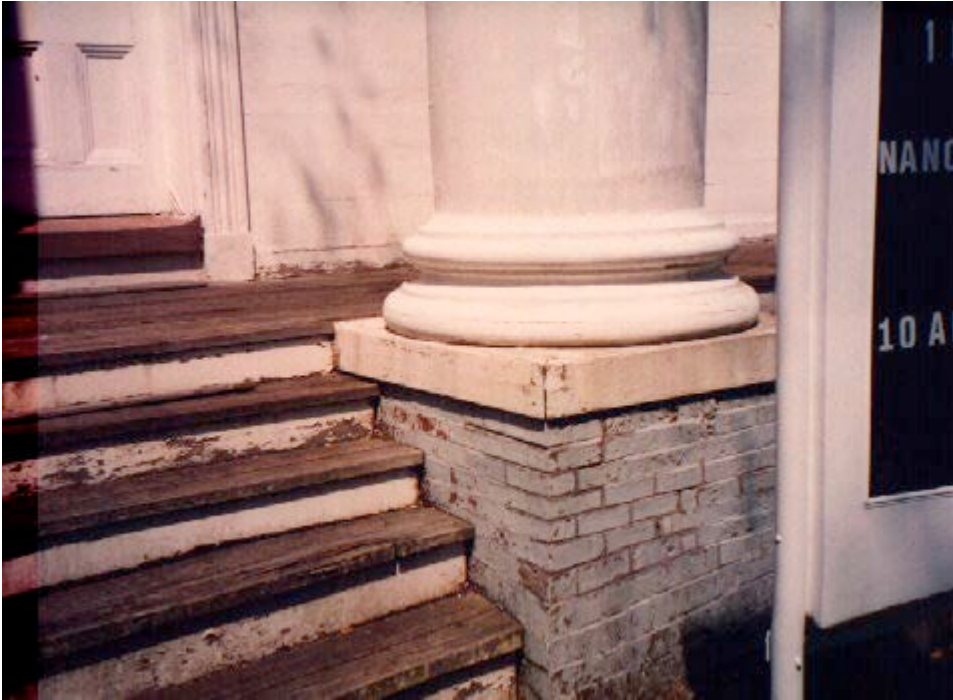
**Figure 9:** Detail of masonry failures, fungal and mold growth and bad mortar match

Masonry units were covered with fungal and mold growth especially where the stairs met the pedestals. Cracked and missing bricks were seen in this area where moisture was held in the masonry units because of improper ventilation at the juncture of the stair. A band of repair mortar had been applied four courses above the missing brick. The mortar was high in Portland cement content, likely making it stronger than the masonry units themselves. This may also have contributed to the cracking and missing joints in the area. Replacement of the wood and re-pointing of the masonry on this base were suggested as well (figs 41-42 CA95).

The re-pointing that was done in repair appears to have been done without considering the strength of the mortar or the appropriate color. Joint size also failed to receive consideration (figs 43-45 CA95). Proper mortar matching is essential to the stability of any masonry construction of repair. When improper mortar is used, the variation in tensile and structural strength can have a profoundly negative effect on the integrity of masonry units, as evidenced on these brick piers.

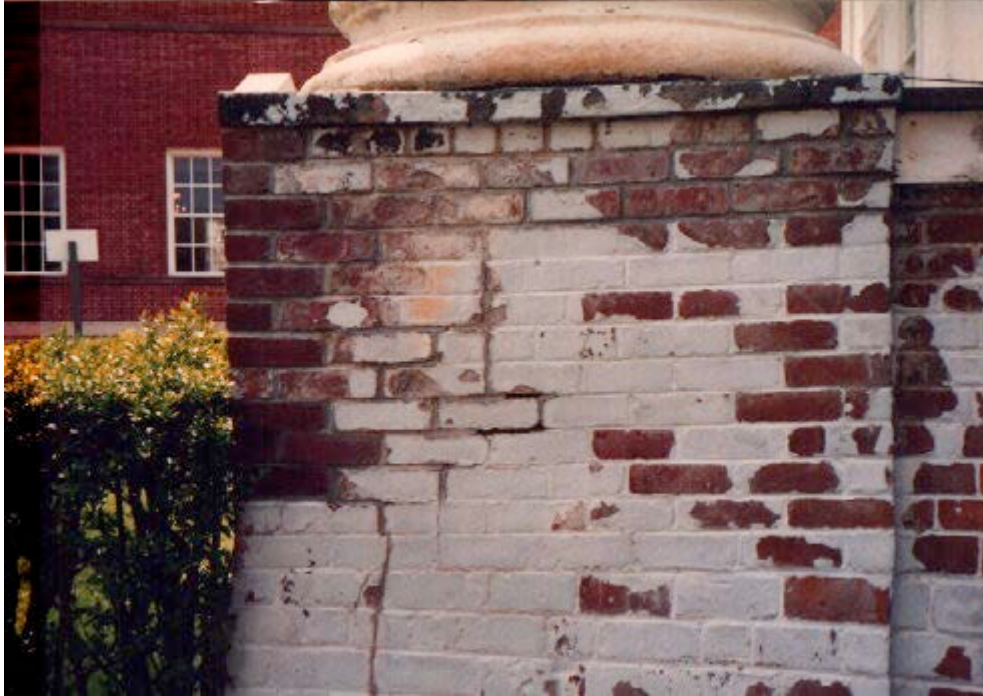
The southeast corner suffered from similar problems. Improper re-pointing, mold growth, and water damage were common here. The presence of organic growth prevented the brick from drying out, which facilitated the deterioration of the base. Step cracking and brick displacement occurred.

**Figure 10:** Partly crushed and missing bricks lead to a closer examination of causes.

Although it was originally planned to address the masonry issues in the first phase of restoration, the conclusion was that the roof loading was equally at fault for the condition of the bases as was the inappropriate mortar and repointing. Therefore, in phase II, we decided to deal with the retrofit of the roof in two stages. First, we would remove the load from the columns through the stabilization and rebuilding of the piers and insertion of structural posts within the columns, then to address the roof itself. With the help of MHC, the piers and columns are now able to support the gable end. In stage 2 of this phase, we shall retrofit the roof itself adding appropriate strength and bracing missing in the construction of 1845.

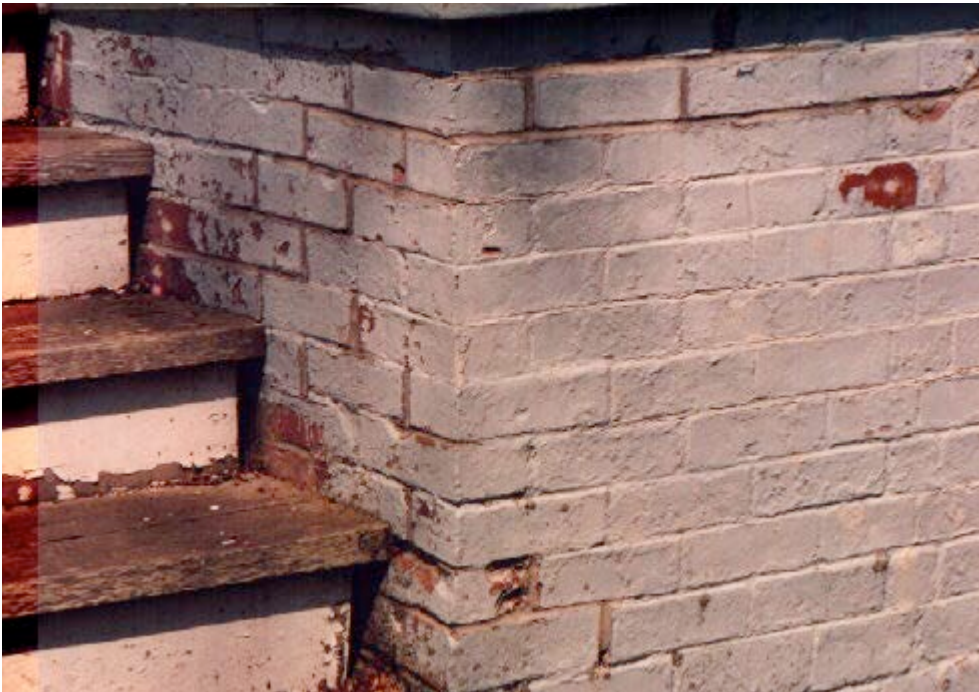
**Figure 11:** Detail of conditions found

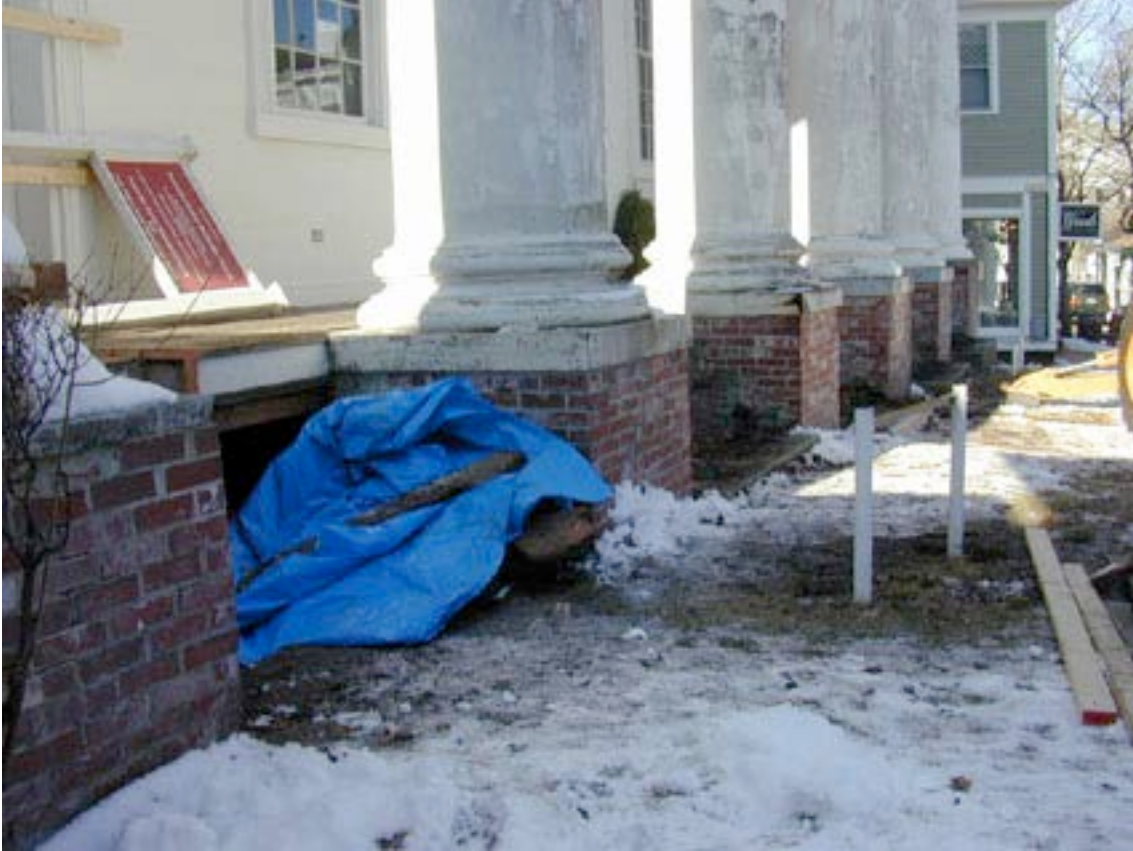
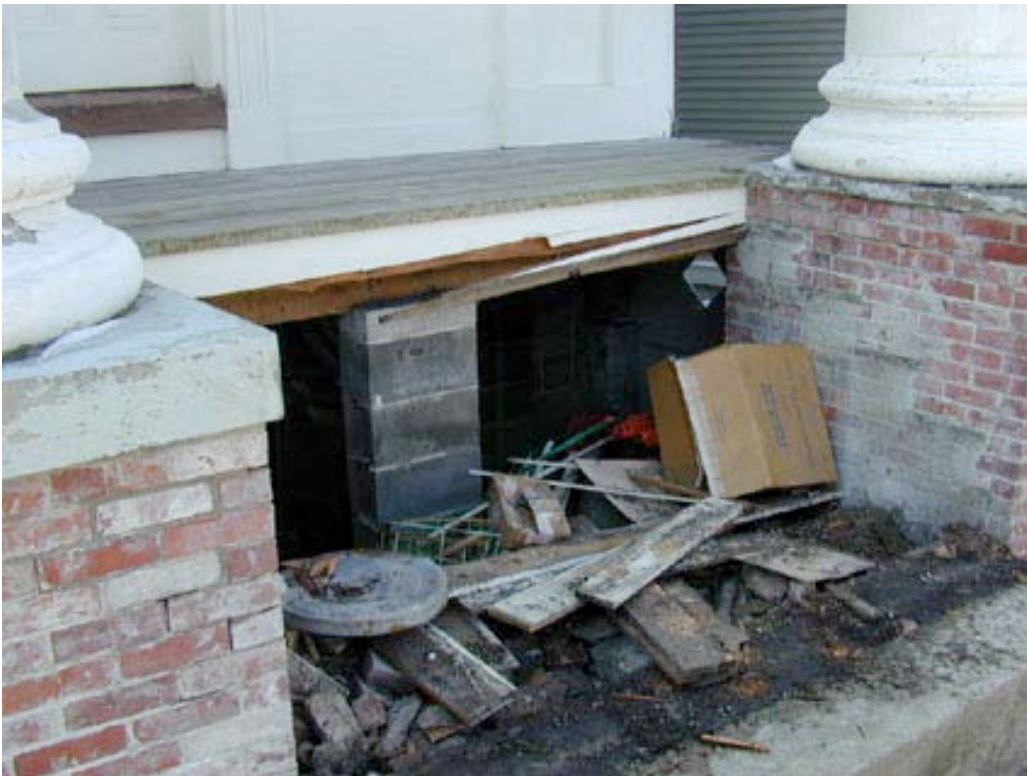
**Figure 13 and 14:** Steps removed prior to demolition and staging. The bases were made of three different materials: granite for the outer columns, concrete on the right two, and wood on the left.

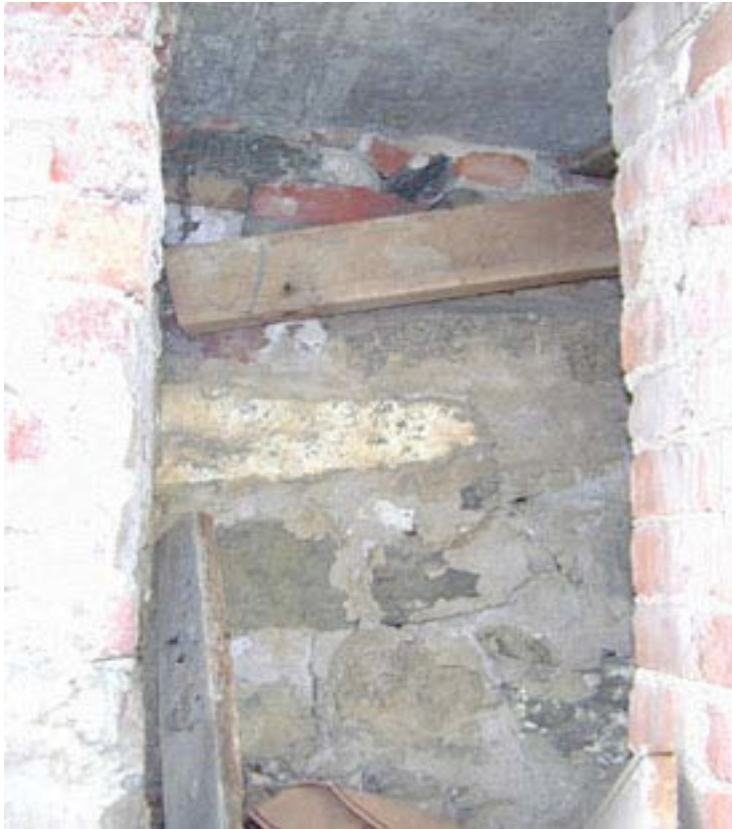
**Figure 15:** Inspection reveals columns supported by rubble. It turned out also that only 3 columns has central post supports remaining.

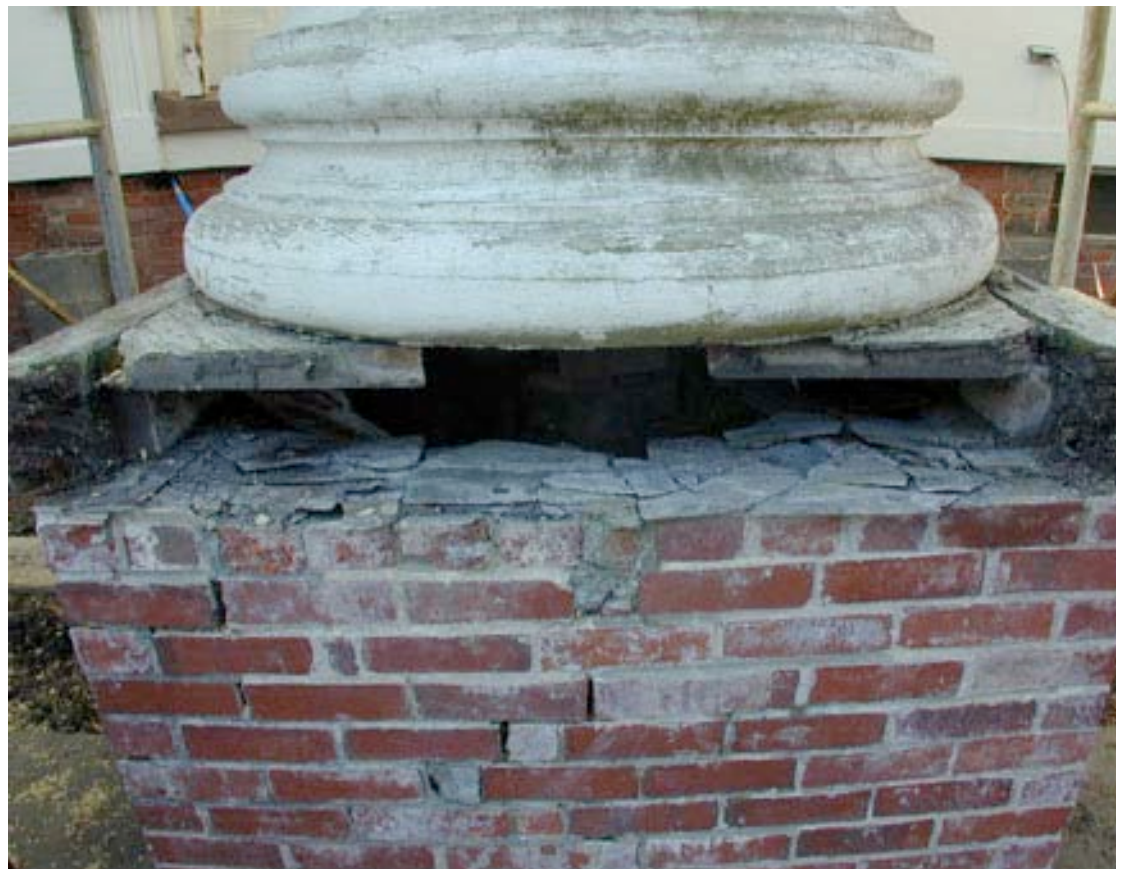
**Figure 16:** Slate roof tiles found between brick pedestal and wood

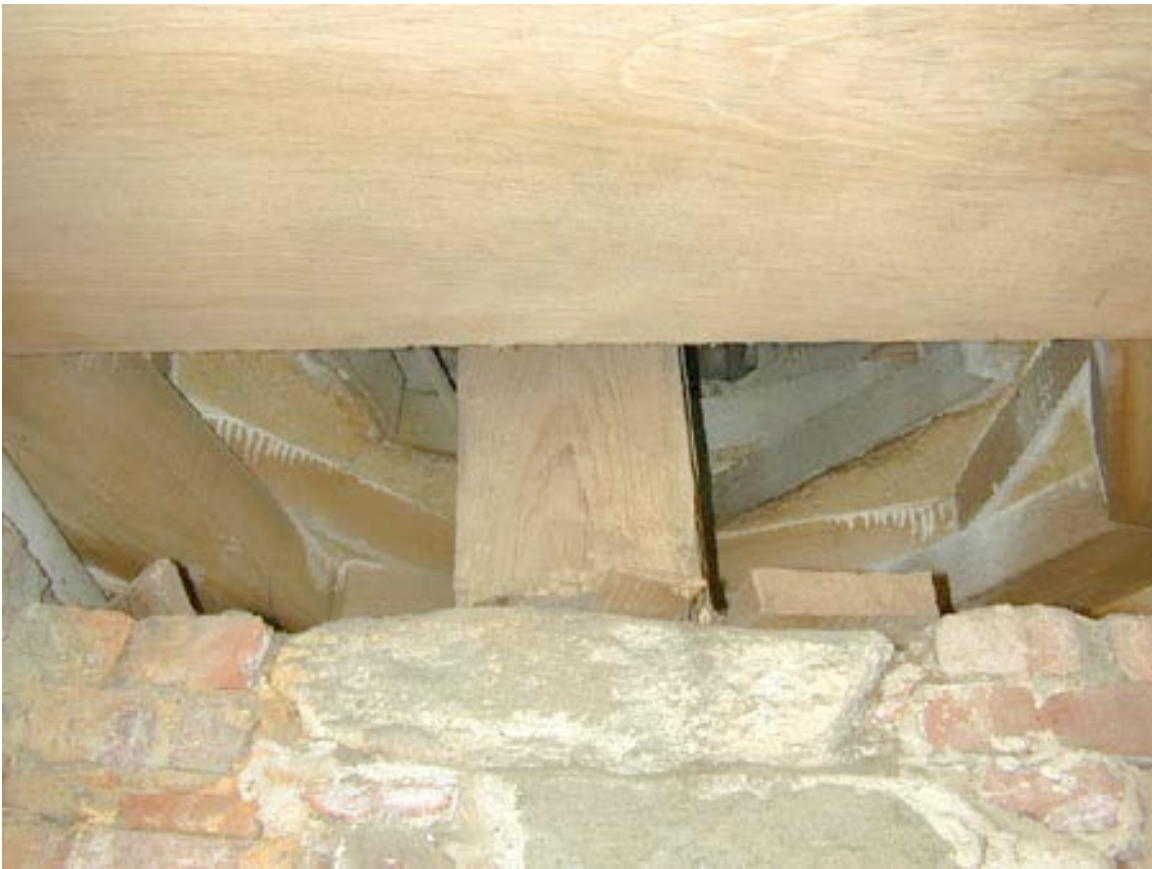
**Figure 17:** Well intentioned 6X6 posts were to carry pediment. Now shims are loose.

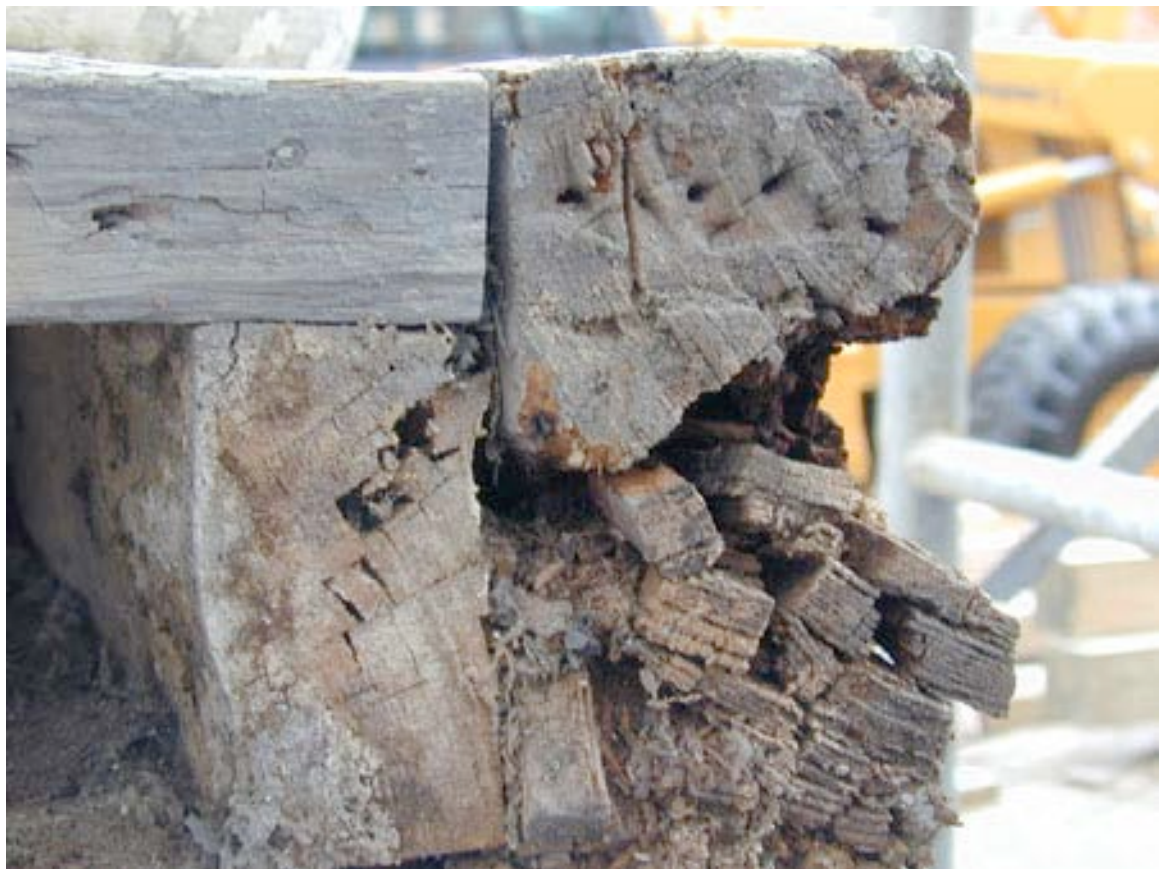
**Figure 18:** Wood bases now severely deteriorated.

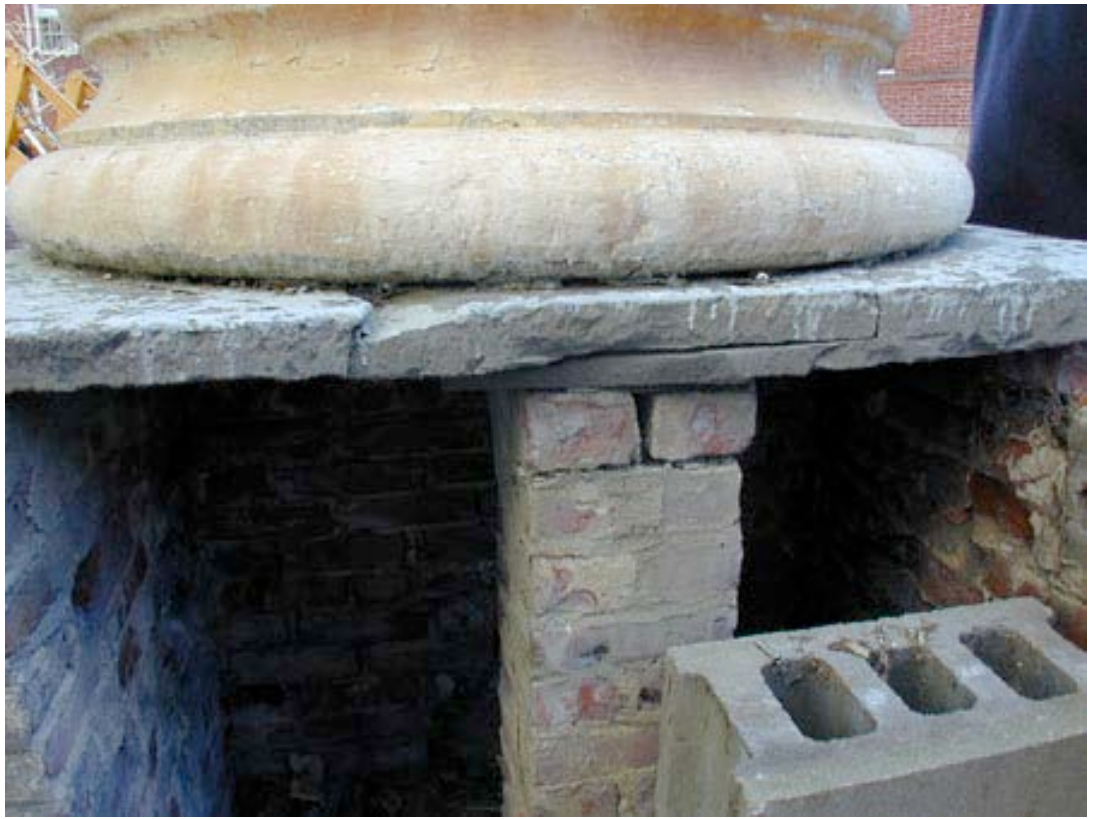
**Figure 19:**  
Stone base is cracked and brick support is failed

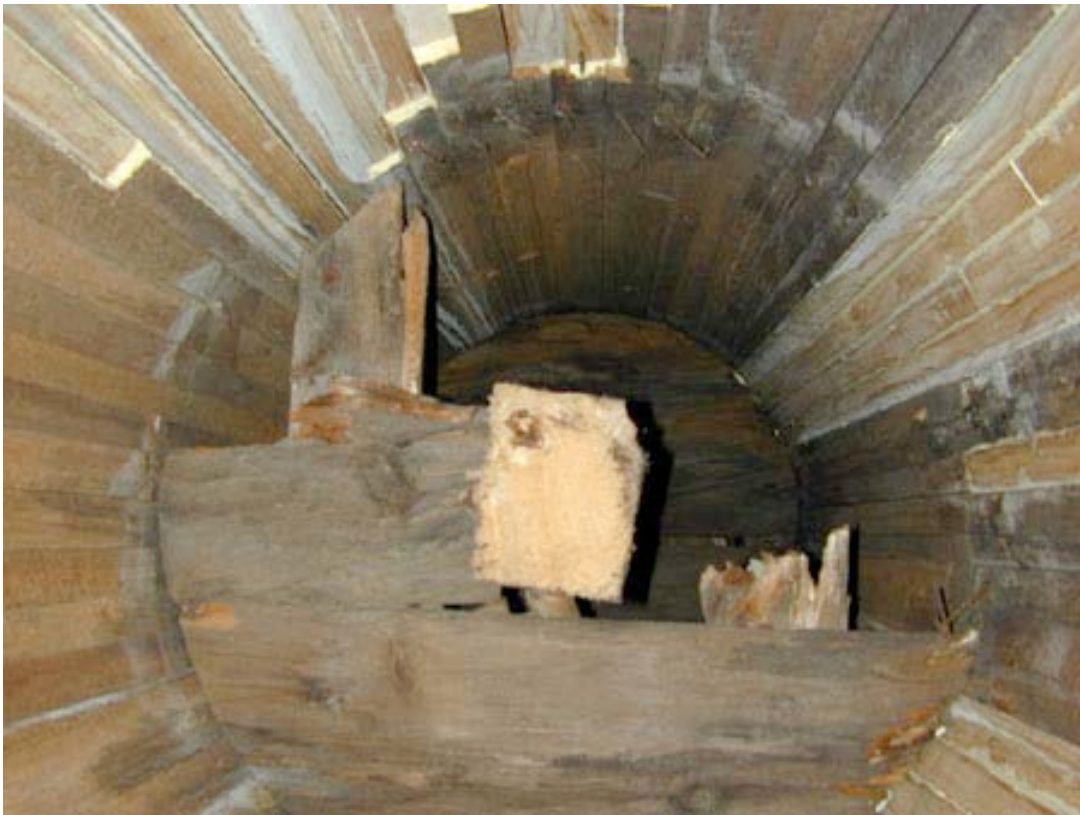
**Figure 20:** Looking up inside column, no more support

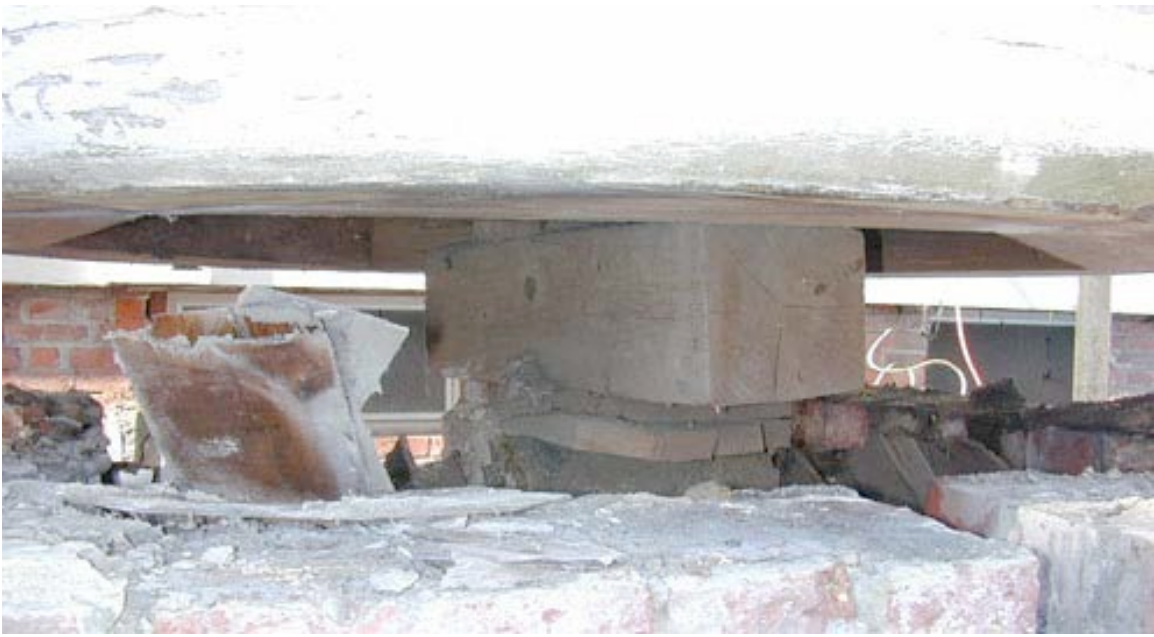
**Figure 21:** all manner of supports were used over time

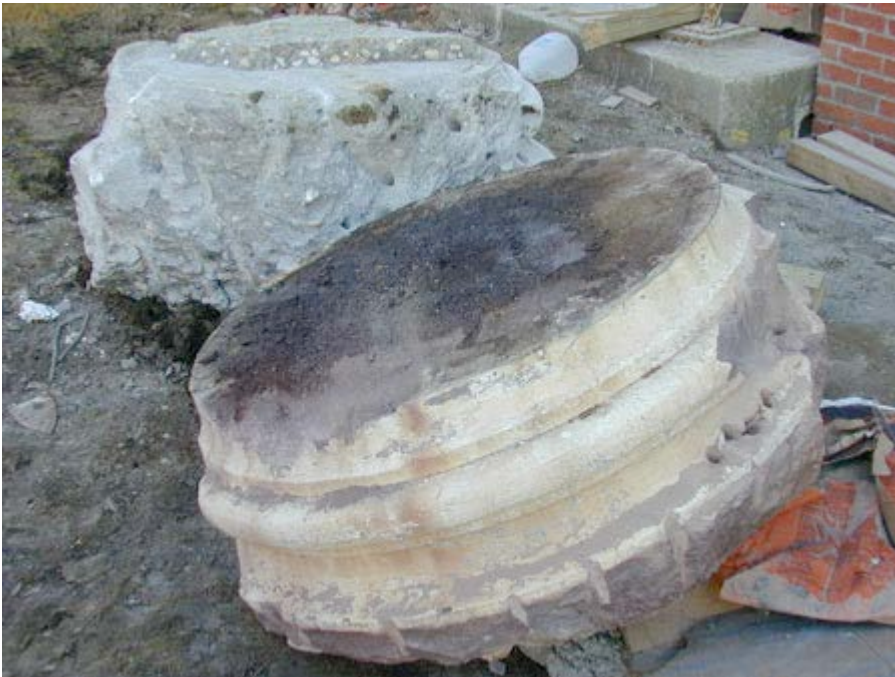
**Figure 22:** A variety of materials made up the bases.

In the initial conditions survey of 1995, the column bases were found to be made of different types of materials including concrete and brownstone. Historic photos determined that the original bases were made of wood. Removal of the existing bases helped to reveal conditions inside the columns and their pedestals. With the existing conditions now assessed behind and underneath the column bases, we could be sure that the diagnosis and remedy were appropriate to the problems.

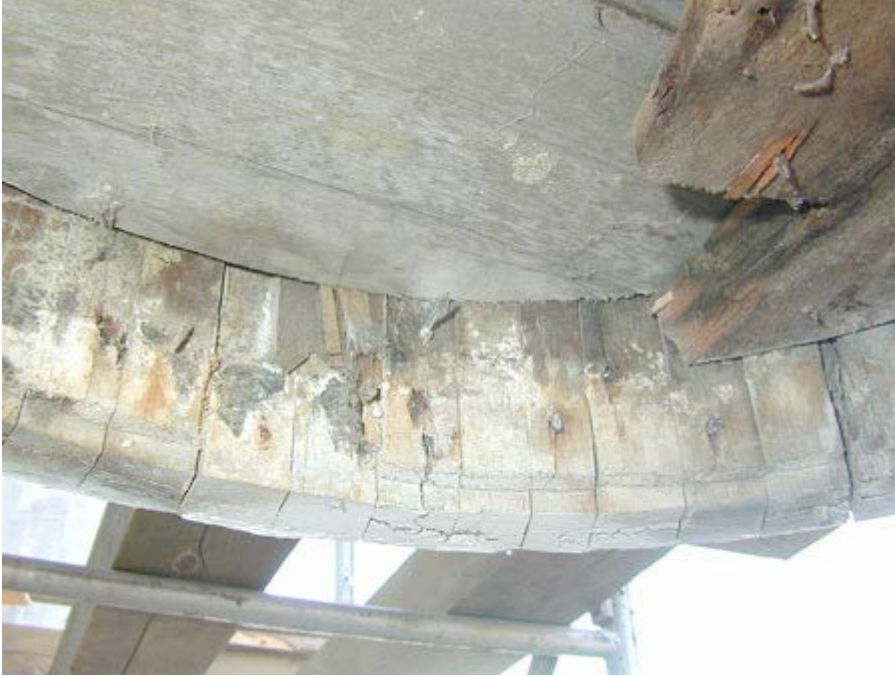
**Figure 23:** Removal of the bases allowed for inspection of the bottoms of the columns. Here the wood is largely intact. Note that rabbeting was used to secure column to base
