d conard b klingberg m rainey
1 interpretive study 2 maintenance assay 3 chronological source material 4 appendix a 5 appendix b		
the methodist church • nantucket, ma. preservation institute: nantucket • 1981

interpretive study the methodist church
	sect. no. 1

1- The original appearance and subsequent alterations to the exterior

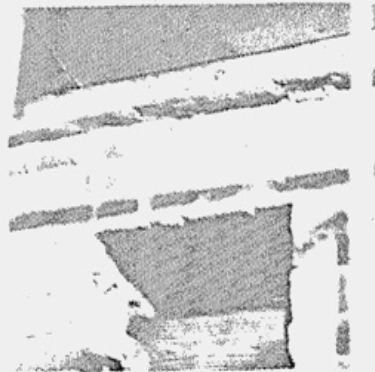
the 1823 door sill

The doors of the Church today are four feet wide with the center door six feet wide with a double hung door; however, an earlier four foot wide doorsill below the sill of the 1840 center door is visible in the furnace room of the basement. The sill of the south door, in the unfinished area of the basement, is also visible and is four feet wide.

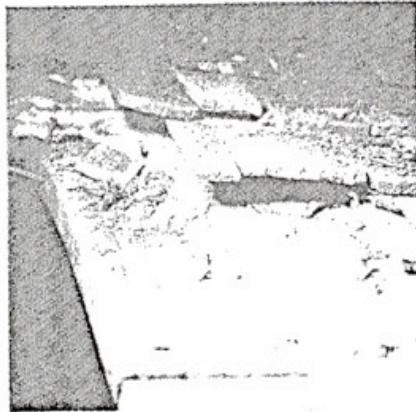
sheathing, plaster and
shingles on the hip roof

The hip roof, completely intact under the gable roof, is the most distinctive feature remaining of the early church. Because the gable roof was built supported on jack rafters rising from the old roof, the hip has been protected entirely from weathering for 140 years and still has its original wood shingles. The roofing of the hip consisted of one inch thick sheathing, often as much as 20 inches wide, spanning 3'-4", covered with a $\frac{1}{4}$ " layer

of plaster, onto which were nailed the 18 inch long shakes with a 5 inch exposure. This lime plaster has no animal hair binder, but has a heavy sand content. Imprints in the plaster indicate that the shingles were nailed to while the plaster was still damp. No nailers were used between the sheathing and the shingles; the cut shingle nails extend through the sheathing in places. The layer of plaster remains an enigma in that it is the only example of such a process that we know. Plaster was used in southern regions under clay tile but not under wood shingles. It is possible that the plaster was intended as a fire protection device to prevent the sheathing from catching in the event that the shingles were on fire.

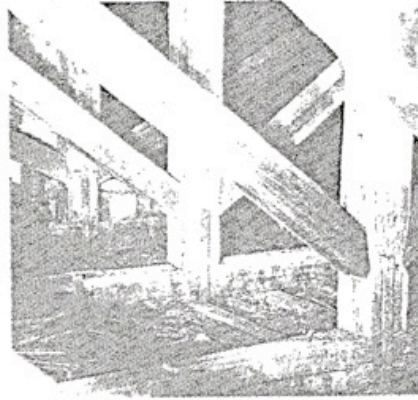
the collar beam between
two rafters

Between the trusses that are 6'-6" o.c. are intermediate rafters to support the sheathing; the rafters are tied with collar beams at third points.

These collar beams are actually in compression due to the downward deflection of the rafters.

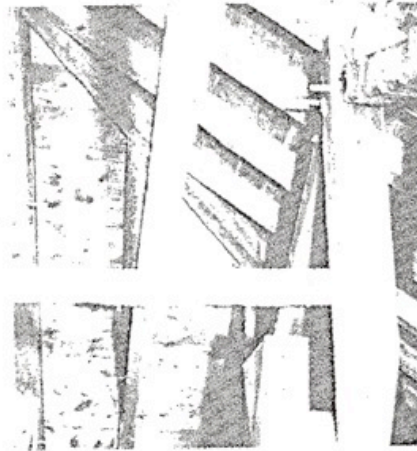
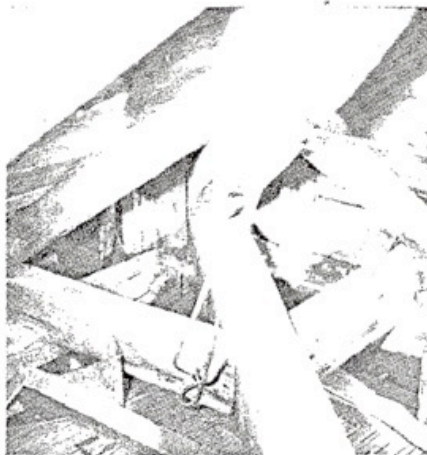
a dragon beam in the corner
of the hip

The structural condition of the last bay of the roof (the east and west ends) are also worthy of note. Ten inch square outlookers, in conjunction with dragon beams at the corners, form a horizontal truss between the sill and the last ceiling beam. This last beam is not a vertical truss, but merely has short jack rafters up to the rafters which are less than four feet above the beam.

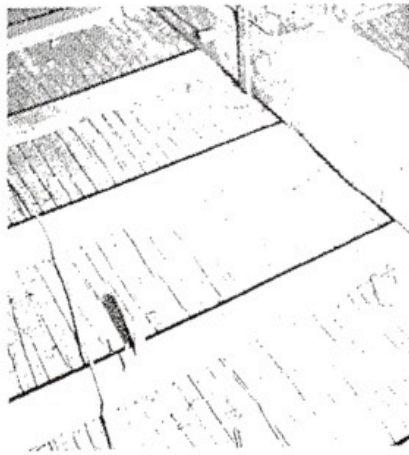
The floor joists nailed to the bottom of the trusses hold rived lath that runs transversely across the structure (north to south). The lath curves down at the junction with the walls on curved cut joists. The original plaster is but tenuously held in place; there is very little key left.

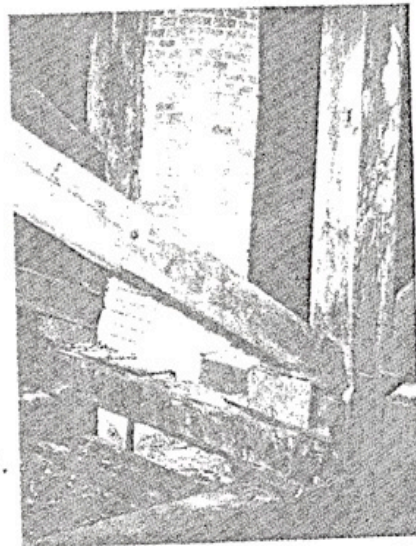
The chimney, set against a king post, pierces the roof in the west hip face.

The chimney in the west end of the roof, hung by metal straps on sleepers laid between the trusses, may have been built originally with the Church in 1823.

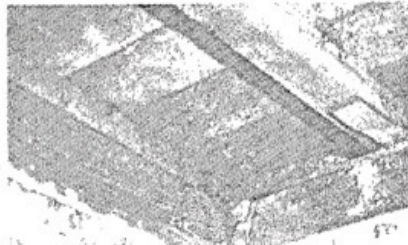
the south sill of wood
and west sill of concrete
block

' A part of the south side and west end of the church has been recilled and the foundations relayed. Where the old sill had decayed, the Church had settled and we found it necessary to raise it and in doing so, the plastering inside the auditorium room was cracked and necessitated repairing and that has been done.'⁶

The repairs to the sill are still very evident in the exposed section of the basement. New brick piers had been built out from the foundation inside the southwest corner to help support the floor beams. The new sill on the south wall, is of wood, a large timber but not hand hewn, and is spliced into the old sill approximately eight feet from the west wall. The southern end of the west sill has been replaced a second time, perhaps when the major excavations were being done in the 1960's.

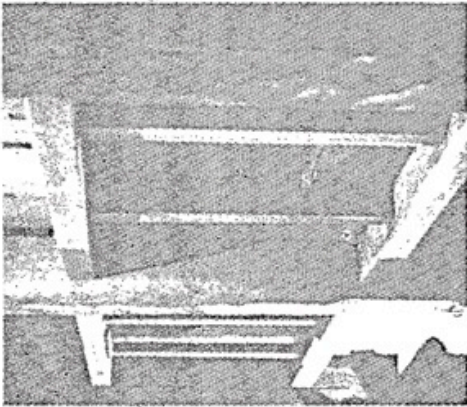
the framing of the side aisle
with clear marks of hand hewn beams

The pews were built integrally with the flooring system. Floor beams, running across the body of the church, were notched for floor joists (just over two feet on center), that in turn supported the floor boards. Within the areas of the pews, the floor boards ran north-south across the Church, but the side aisles were framed out and the joists turned the opposite direction so that the floor could run longitudinally (east-west). This is documented in the project drawings in Appendix E of this paper. A slot was cut in the edge of the aisle flooring, 1 x 17 inches, to accept the end board of the pews; this can be seen clearly at the west end of the south aisle where the pews were removed in 1844.

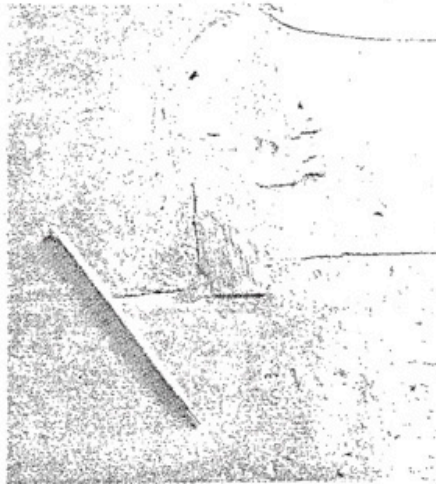
a post plug approximately
1 3/4" x 3 1/4"

The center back post of each pew is set into a hole cut out of the floor boards; it is this detail that enables us to read the areas of original flooring in the sanctuary. When the pews were turned, the posts were cut off level to the floor, leaving the end of the post to plug the hole. Locating each plug

on a plan of the sanctuary indicates that the center section of flooring, 12 feet from the west wall extending 45 feet to the east, has not been altered; the post marks are all in line in both directions and equally spaced- except for variations of an inch or two caused by the posts not being plumb and the pew hacks not being perfectly in line. A portion of these center pews can be seen from the underside in the basement, and it is evident that the original floor framing is still in place.

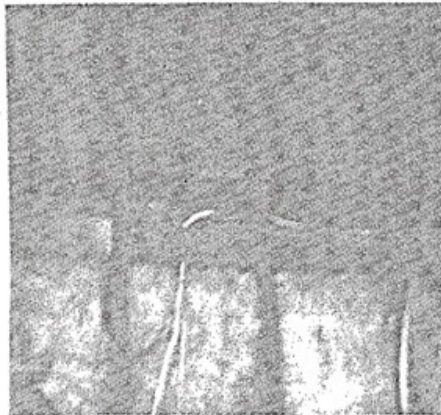
stepped pews
specially cut
piece of board

Although the reference in 1844 in the Trustees Record is to making the floor level^a, specifically in the west where apparently a section of pews were raised, it seems that the raising of the side pews and the stepping

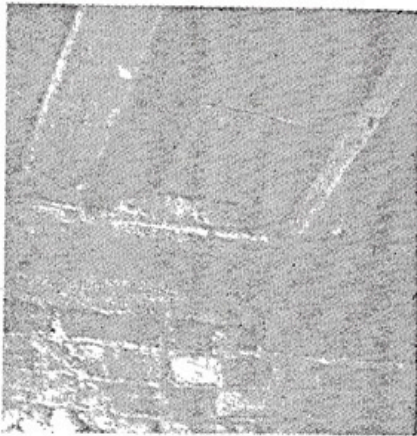
the post on west wall,
which could have helped
to support the gallery

Because of the reference to removing it in 1845, we know a west gallery had existed prior to that date. There is an intermediate post on either side of the west wall on line with the front edges of the north and south galleries. This is visible from below in the unfinished portion of the basement. It appears that the second piers in from the west wall, although they are boxed over square, were notched away just below the top edge of the balcony. This is where a beam could have angled down, in conjunction with a beam from the west post, to support the corner of the west balcony. The balcony would then have been approximately eight feet wide, narrower than the width of the north and south balconies.
