d conard b klingberg m rainey
1 interpretive study 2 maintenance assay 3 chronological source material 4 appendix a 5 appendix b		
the methodist church • nantucket, ma. preservation institute: nantucket • 1981

interpretive study the methodist church
	sect. no. 1

1- The original appearance and subsequent alterations to the exterior

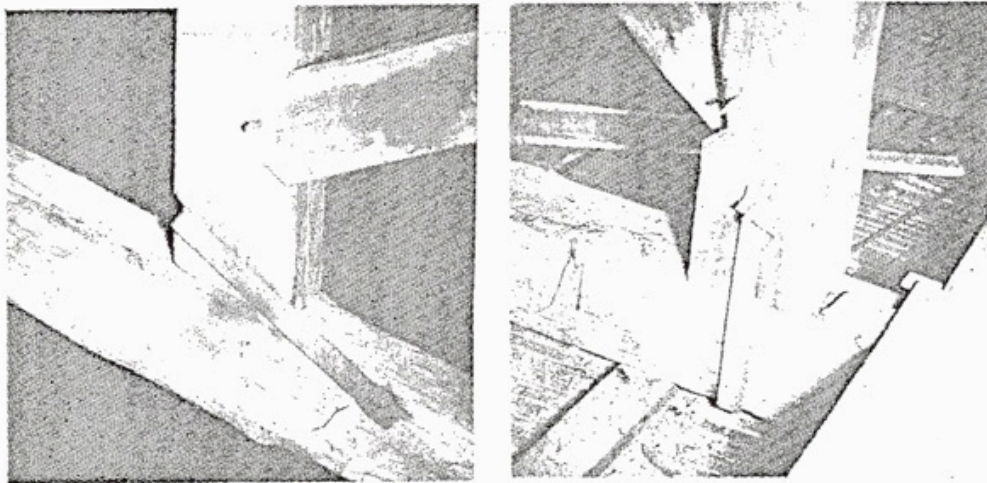
sheathing, plaster and
shingles on the hip roof

The hip roof, completely intact under the gable roof, is the most distinctive feature remaining of the early church. Because the gable roof was built supported on jack rafters rising from the old roof, the hip has been protected entirely from weathering for 140 years and still has its original wood shingles. The roofing of the hip consisted of one inch thick sheathing, often as much as 20 inches wide, spanning 3'-4", covered with a $\frac{1}{4}$ " layer

of plaster, onto which were nailed the 18 inch long shakes with a 5 inch exposure. This lime plaster has no animal hair binder, but has a heavy sand content. Imprints in the plaster indicate that the shingles were nailed to while the plaster was still damp. No nailers were used between the sheathing and the shingles; the cut shingle nails extend through the sheathing in places. The layer of plaster remains an enigma in that it is the only example of such a process that we know. Plaster was used in southern regions under clay tile but not under wood shingles. It is possible that the plaster was intended as a fire protection device to prevent the sheathing from catching in the event that the shingles were on fire.

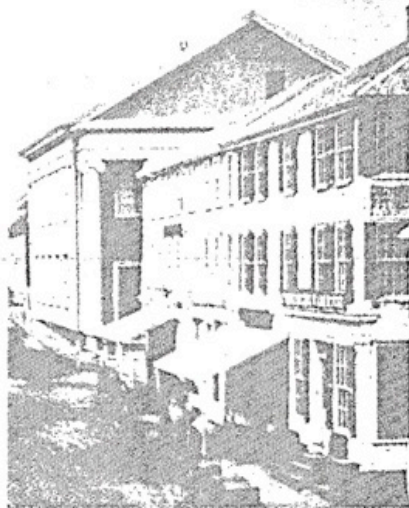
The Methodist Church and Main Street before the Great Fire of 1846.

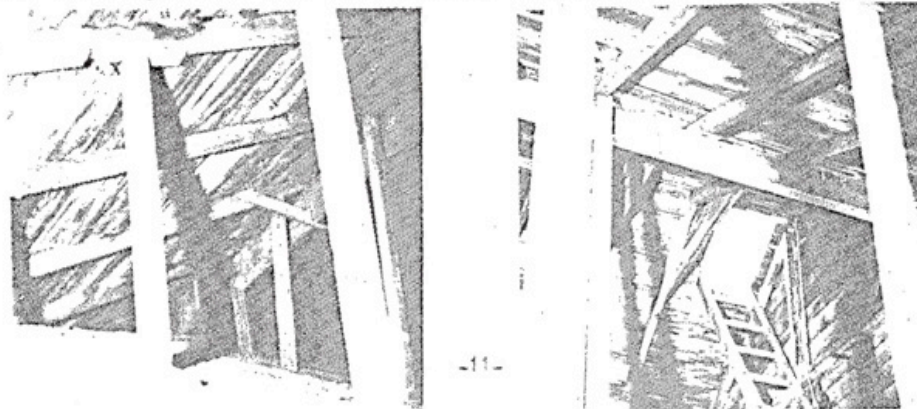
the new gable roof sprung. The ridge rested, in part, directly on the hip ridge and on the ends was constructed with a proper ridge beam that abutted the hip. It is possible to see the connection of the two ridges through the scuttle opening in the hip accessible by a ladder. Between the ridge and the entablature, the rafters of the gable are supported by jack rafters toenailed directly onto the shingled roof with small pieces of scrap wood nailed on as a footing.

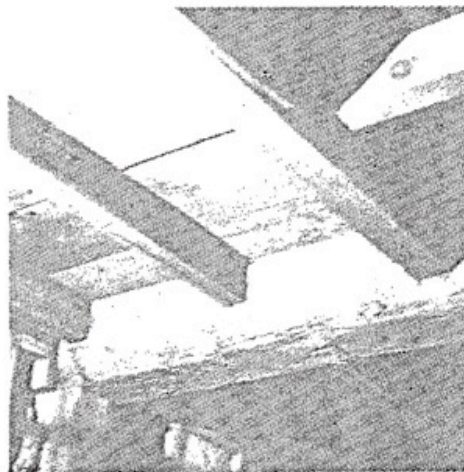
under the center section of pews

on a plan of the sanctuary indicates that the center section of flooring, 12 feet from the west wall extending 45 feet to the east, has not been altered; the post marks are all in line in both directions and equally spaced- except for variations of an inch or two caused by the posts not being plumb and the pew hacks not being perfectly in line. A portion of these center pews can be seen from the underside in the basement, and it is evident that the original floor framing is still in place.

a post plug approximately
1 3/4" x 3 1/4"

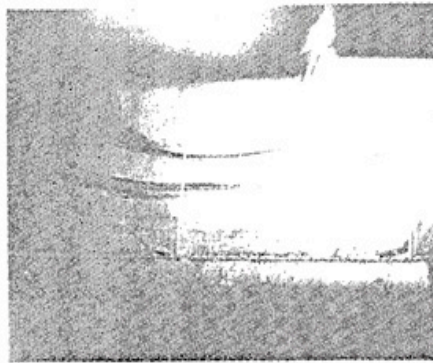
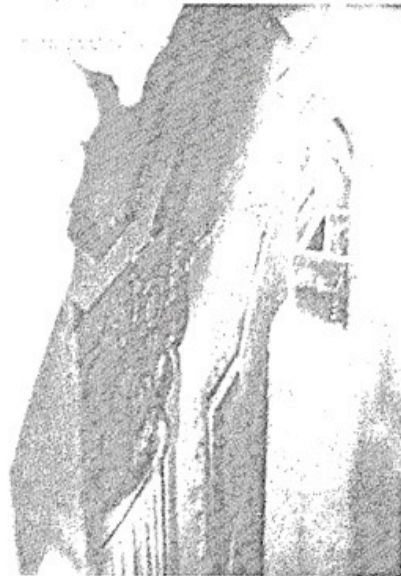
was formed behind the altar. There is no mention of it being decorated until a minister's report at a Quarterly Conference stated that between 1878 and 1880, a trompe-l'oeil 'fresco(d) back of the pulpit'® inside the niche and a border painted round the opening. This fresco, hidden when the organ was moved in front of it in 1893, is still visible from a vantage point above and to the side of the organ. It is also partially visible between the pipes of the organ. There are three Corinthian columns supporting a doubled arch. The 'floor' between the columns is painted to recede, giving the trompe-l'oeil effect. The fresco, however, does not fill the entire space of the niche; the sides feathering off about a foot away from the edge. This leads us to believe there may have been some kind of concealment at the sides of the niche.

The decorative border is still visible at the top of the arch where it has not been painted over. About eight inches wide and comprised of several rows of painted moldings and beads, it is topped with a swirled design.

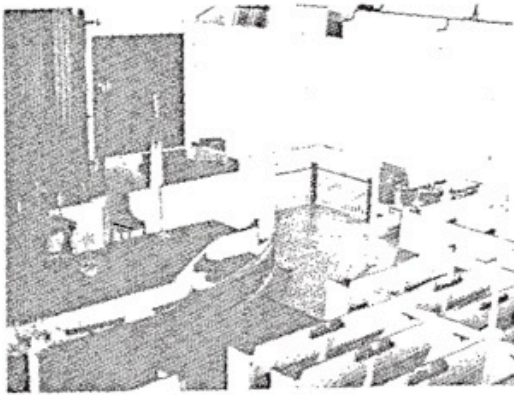
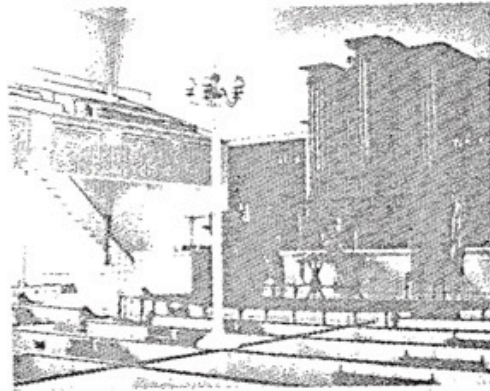
the 1949 construction

Because of fire code regulations, a second stair from the balcony was required and built in the southwest corner of the sanctuary. The corner pews had already been removed when a door was placed in the west end, opposite the side aisle, perhaps in 1904 when various renovations
